ALPINE RESORTS LAND STABILITY

Review of alpine resorts land stability in Victoria

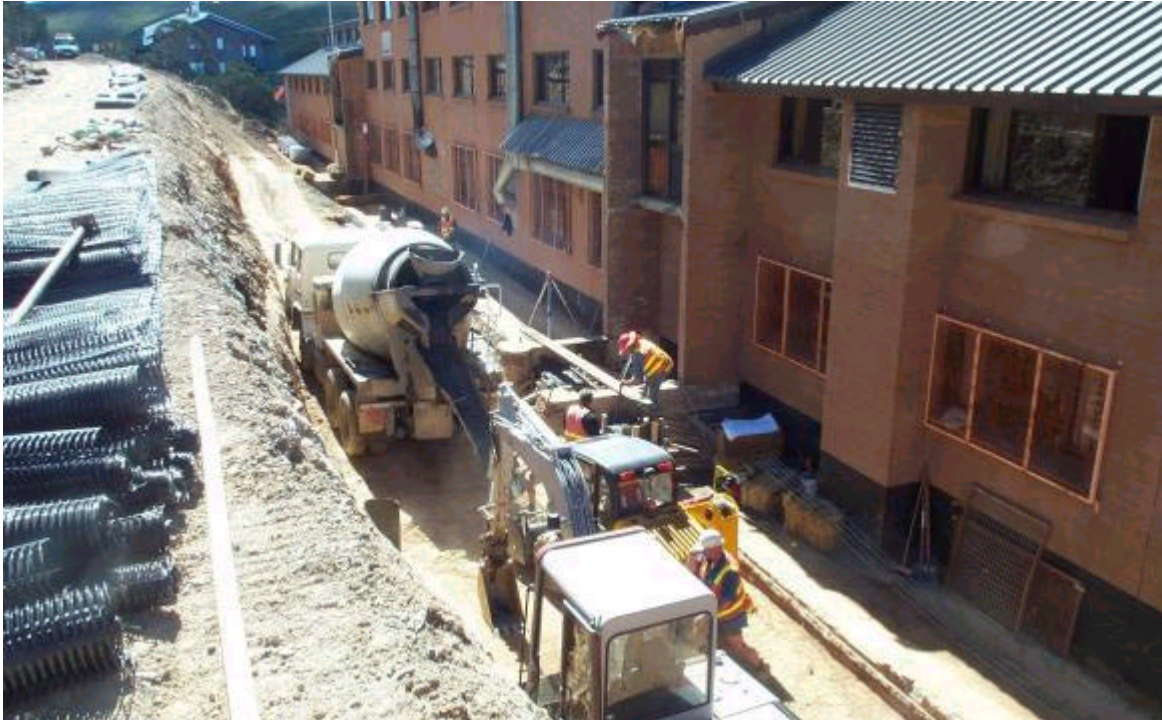
- Inadequately supported cuts into the hill slope at 2 sites at Mt Hotham, which required emergency remedial works to be commenced in late 1999. These works included the replacement of a damaged crib retaining wall behind one of the lodges. Detailed geotechnical investigations also recommended the immediate decommissioning and replacement of a water main at the resort; and

Remedial works being carried out at Higgi Drive, Mt Hotham, behind the Arlberg apartments.

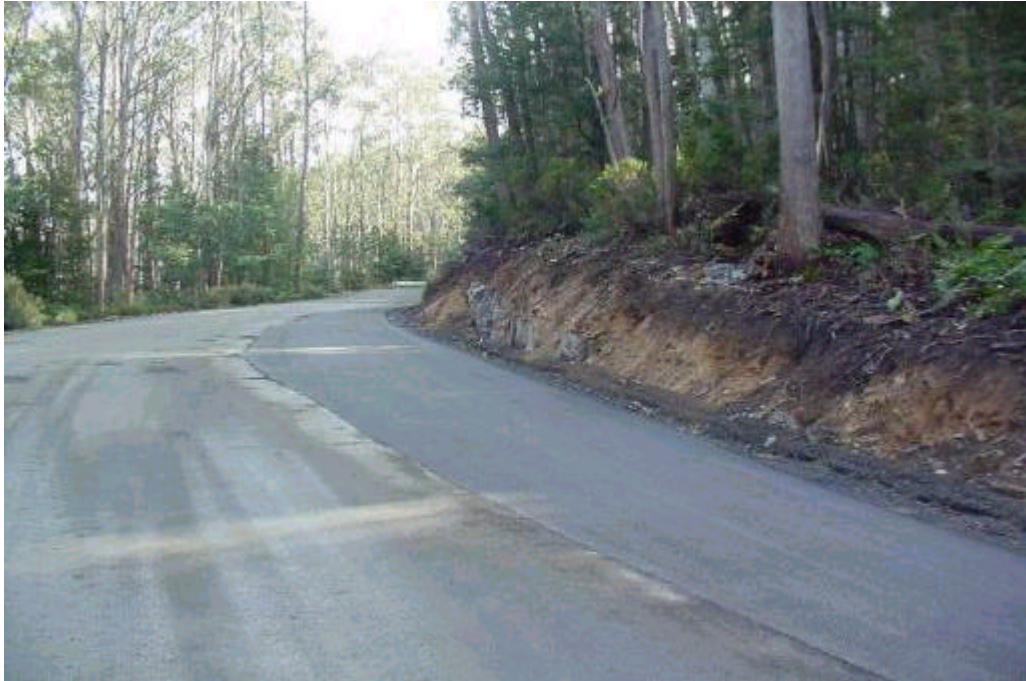
3.5.207 A comprehensive review of sections of the access road at Mt Baw Baw, not previously assessed, was also scheduled to be undertaken during Stage 2 of the remedial works program in order to identify and investigate other locations that may be prone to instability.

*Repaired pavement - Mt Baw Baw access road.
(Photo courtesy of the Department of Natural Resources and Environment.)
Asset maintenance*

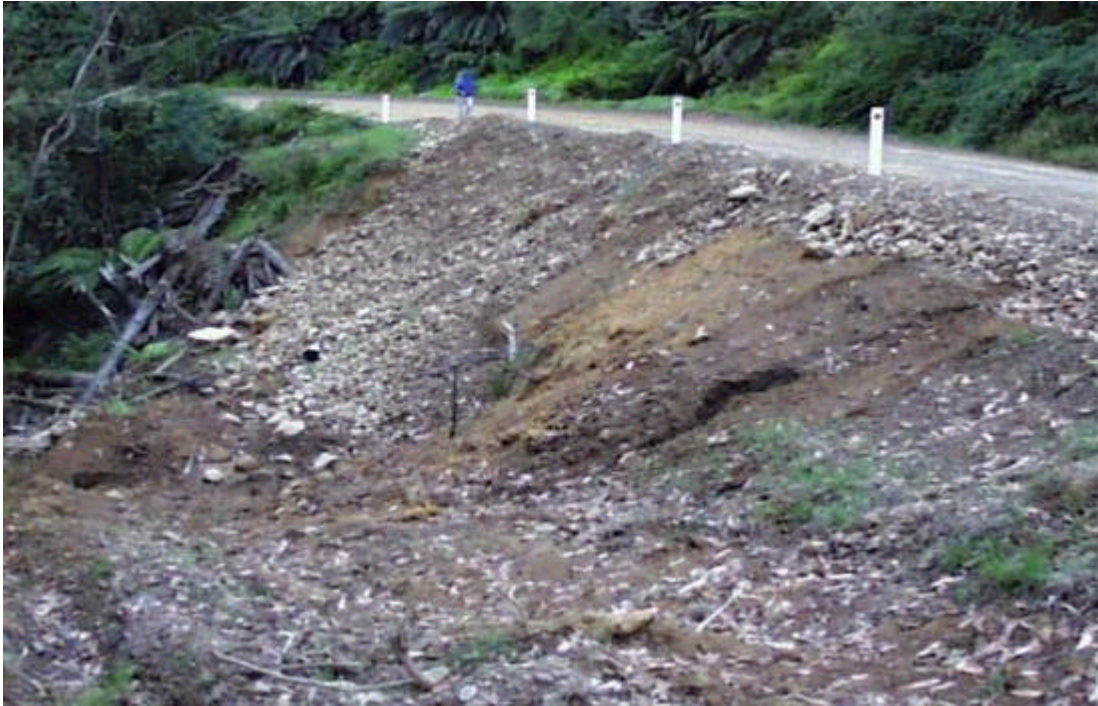
3.5.223 The Mt Stirling Alpine Resort Management Board has advised that without additional funding it will be very difficult for it to keep the access road properly maintained. This was confirmed by a risk assessment undertaken by geotechnical consultants in August 2000, which found that the alpine access road maintenance program at Mt Stirling has been deficient over several years and recommended that, as the roads at the resort are used as long-term public access roads (despite not being designed or built as such) they need to be managed in a manner that recognises that problems with road safety are likely to arise in the future.

Mt Stirling access road needing repair.
