ALPINE RESORTS LAND STABILITY

Review of alpine resorts land stability in Victoria

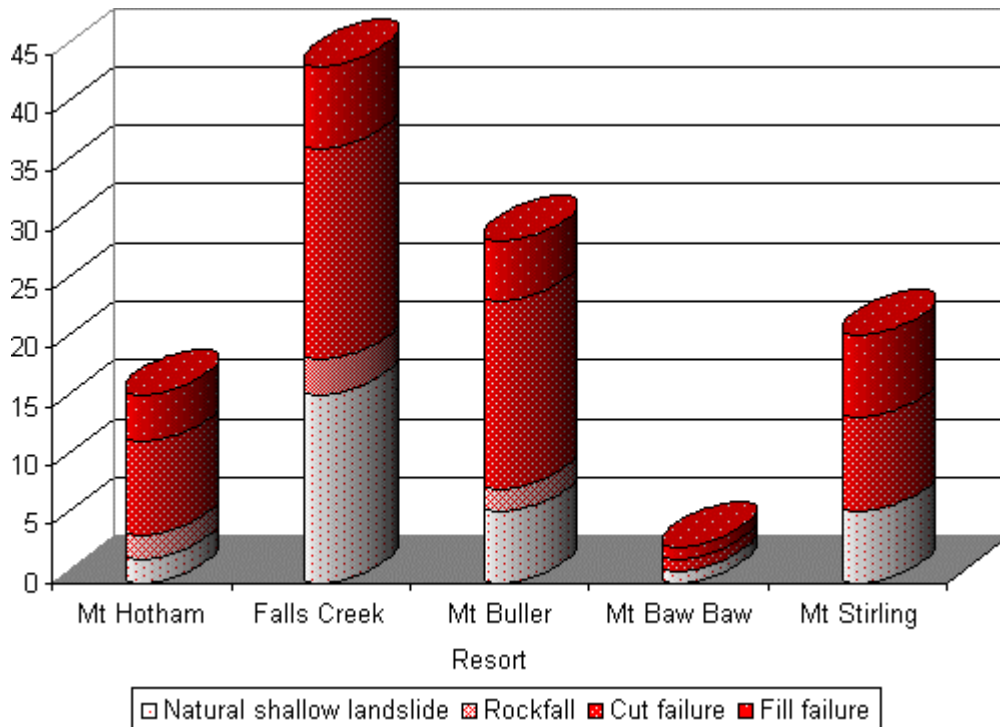
**CHART 3.5Q
INSTANCES OF EACH TYPE OF INSTABILITY AT EACH RESORT,
RATED AS A HIGH OR VERY HIGH HAZARD**

3.5.191 Of the 660 sites assessed, 76 were rated as either a high or very high hazard, with many sites at risk of more than one type of instability. Lake Mountain, which had very little development, was the only resort to have a low to very low hazard rating for all its sites.

3.5.192 Chart 3.5Q below discloses, for each type of instability, the instances of high or very high hazard at each resort.
