2010/11

Falls Creek Alpine Resort Management Board

Water Supply Annual Report

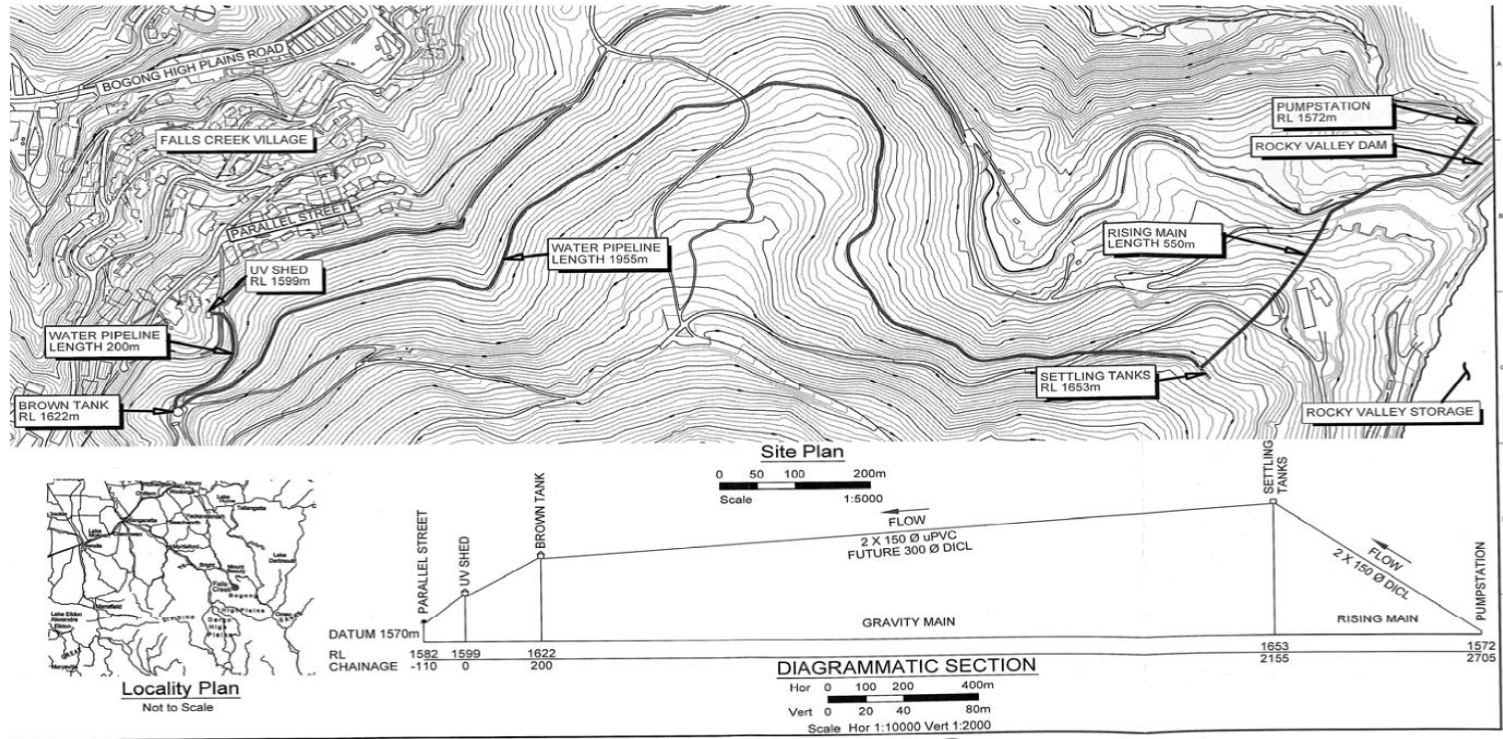
Figure 1 – System Diagram

Reticulation	Network of pipelines delivering to consumers within the village	Total of almost 4 km reticulation system of predominantly 100mm to 150mm diameter DICL pipe.
Water Sample Locations	Falls Creek	Horseshoe Creek Apartments, Falls Creek Road Alpha Lodge, Parallel Street Administration Building, BHP Road Sewerage Treatment Plant FCRM Workshop, BHP Road Technical Services Building, Snowgum Lane Gully Shelter, BHP Road Milch, Schuss Street Lift Company Building, Village Bowl Primary School, Slalom Street
Populations Supplied	120 (Summer) to 5000 (Winter)	
Substances Added	Nil

Falls Creek Water Supply System Map
Figure 1
Drawing No. 2004458/M01

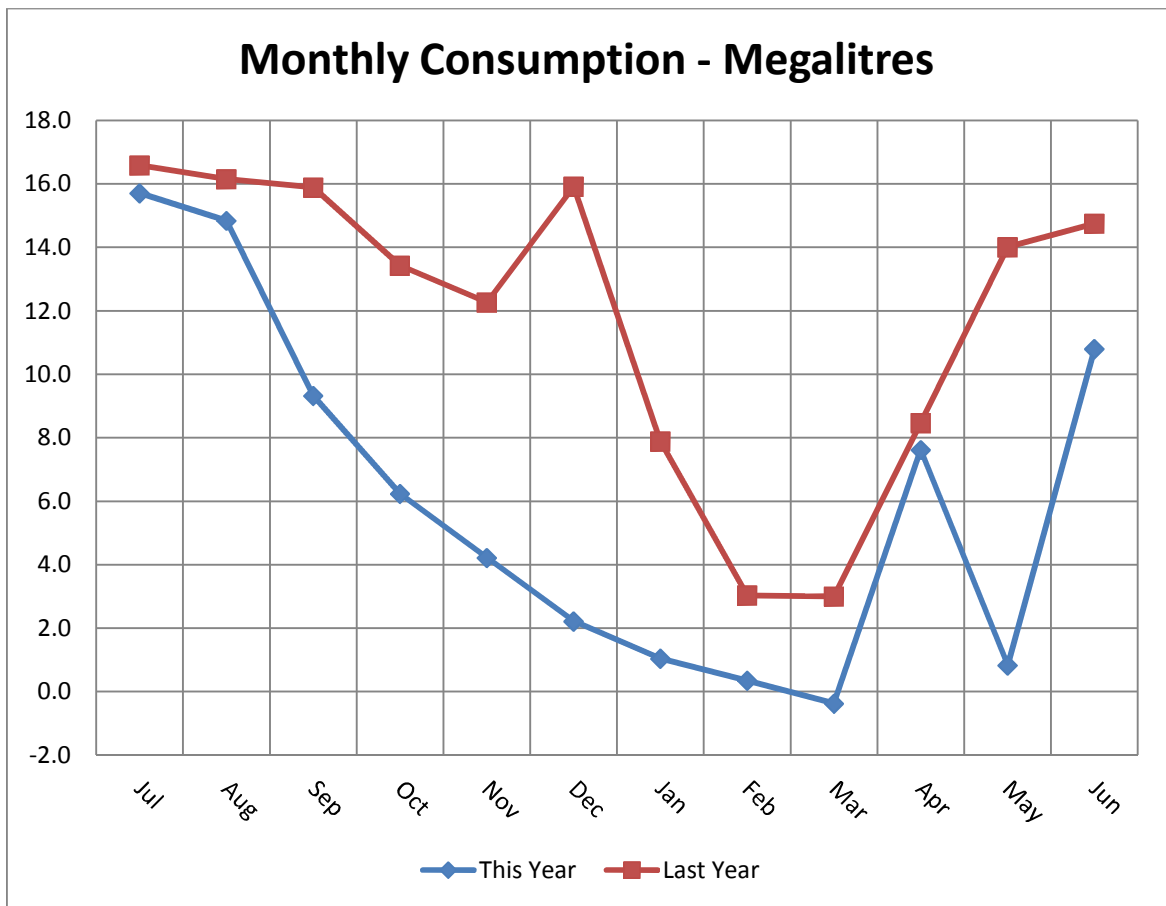
The significant decrease in consumption is attributed to the very wet conditions during the late spring and summer of 2010-11 with 1,082mm of rain recorded in the five months from November to March (inclusive).

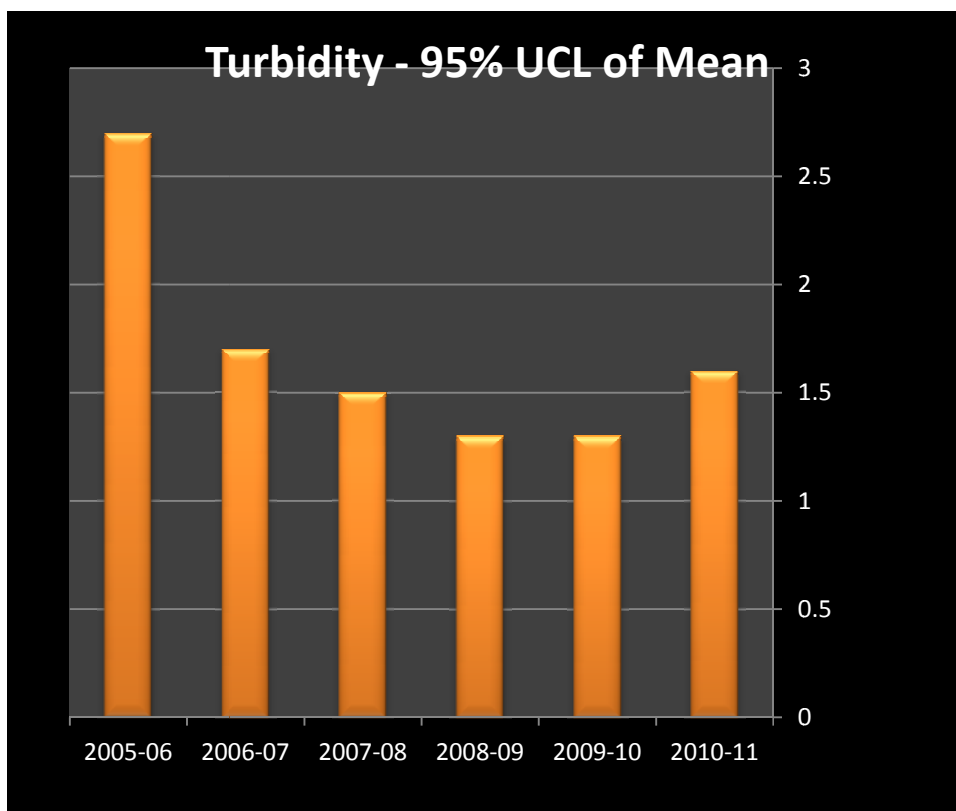
Improved operational procedures in relation to the source water in the last 3 years (refer also to section 4.3) has seen a gradual improvement in the 95% upper confidence limit of the mean as demonstrated in the graph below.

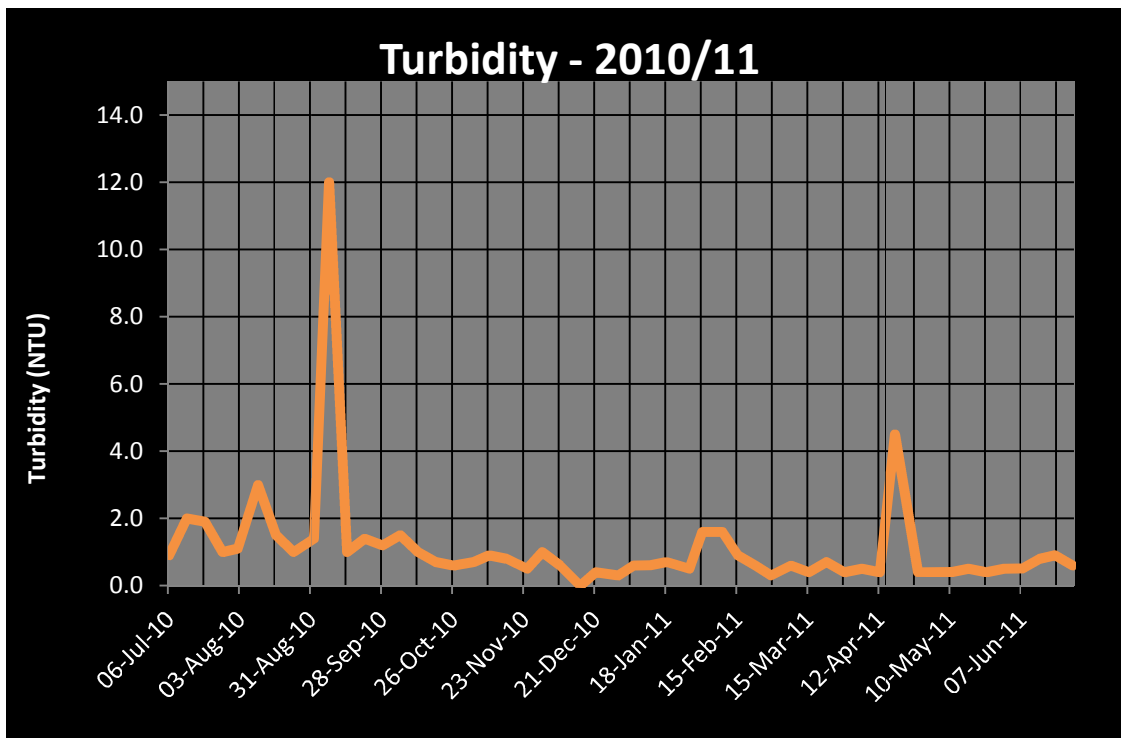
Weekly turbidity readings for the year are show graphically below.

Since the commencement of weekly turbidity and bacteriological testing in August 2004, 42 of 350 or less than 12% of samples have produced a turbidity reading higher than 2.0 NTU.

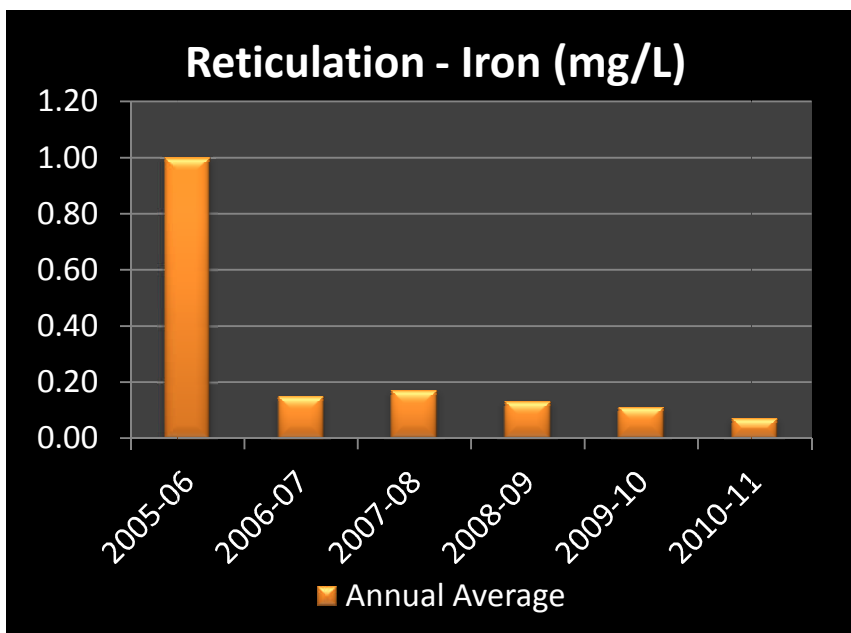
The water quality test results show that the source water supply suffers from dirty water problems in late summer and mid-winter. This is due primarily to elevated levels of dissolved iron and manganese which causes a characteristic brown tinge to the water. Improved operational responsiveness to the change in quality of the source water by taking supply from alternative sources (aqueduct or the snow making system) during periods of stagnation in summer started in 2006-07. This has produced a marked improvement in the iron levels in the reticulated supply. The trend in dealing with this issue is demonstrated in the graph of annual average levels shown below. For further detail refer also to section 4.3 below.

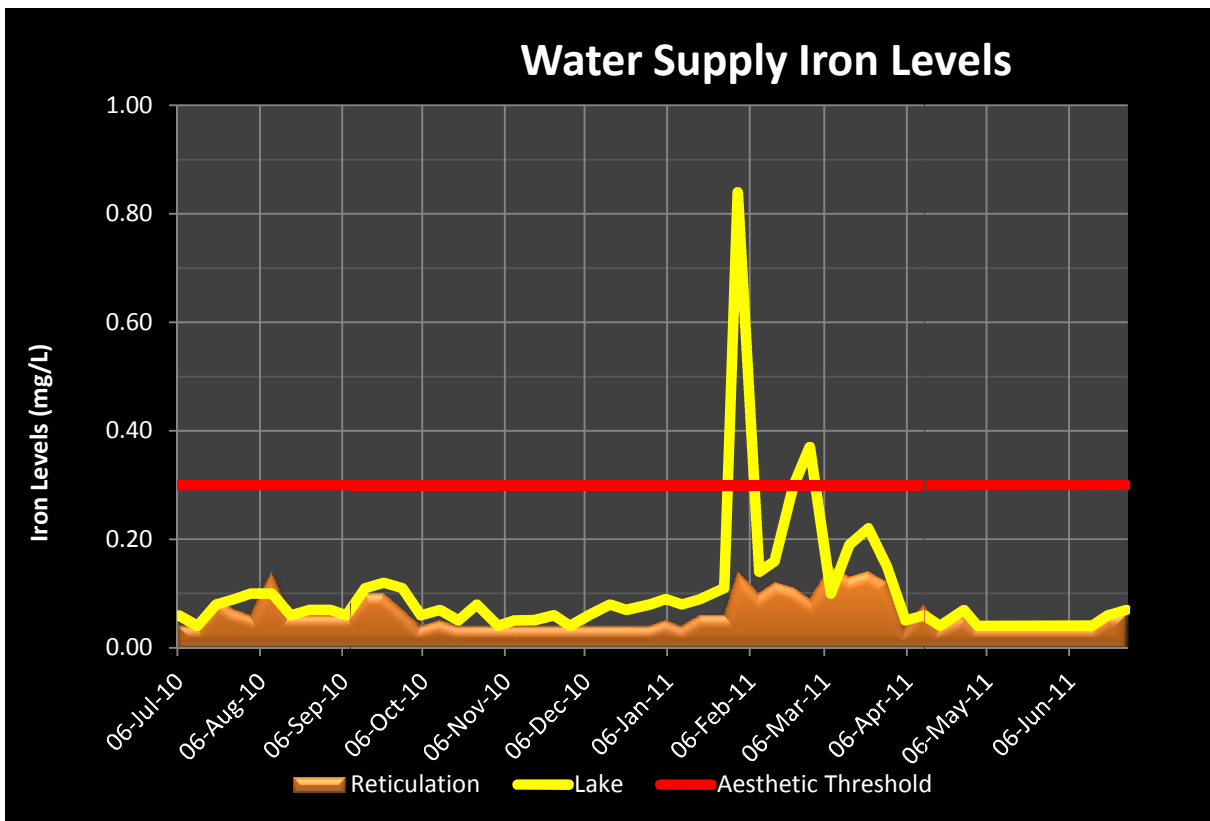
A diversion pipe was installed last year to harvest water from the aqueduct by conveying it into the existing pump station at the base of the Rocky Valley Lake. This water was then pumped via the existing rising main into the settling tanks for the duration of the lake stratification event with excellent results. The peak iron level measured in the reticulation was 0.15 mg/L whereas the peak lake reading was 0.84 mg/L. Weekly iron level readings for the lake and reticulation during the reporting period are shown graphically below.
