Water Quality Annual Report

2014/15

Falls Creek Alpine Resort Management Board

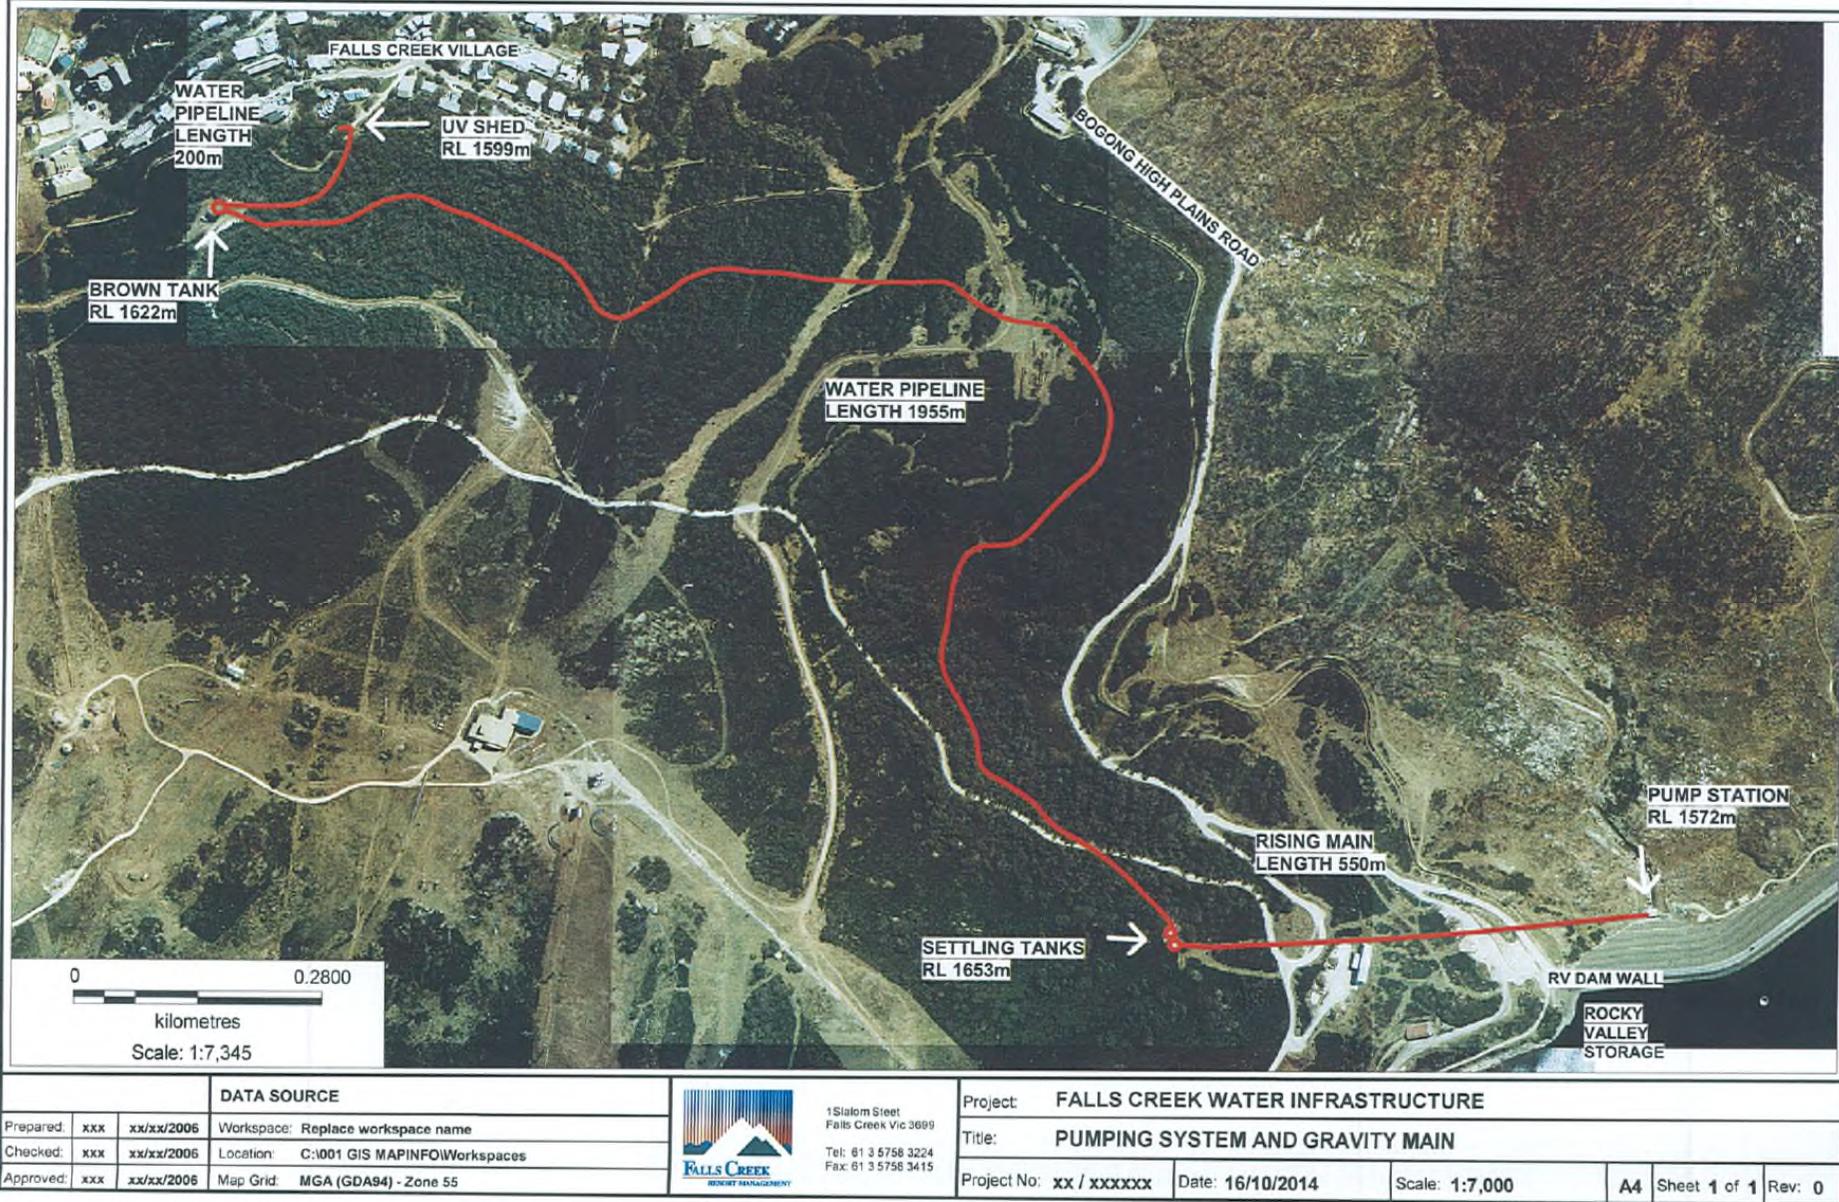
Figure 1 – System Diagram

Reticulation	Network of pipelines delivering to consumers within the village	Total of almost 4 km reticulation system of predominantly 100mm to 150mm diameter DICL pipe.
Water Sample Locations	Falls Creek	(960A01) Horseshoe Creek Apartments, Falls Creek Road (960A02) Alpha Lodge, Parallel Street (960A03) Administration Building, BHP Road (960A04) Sewerage Treatment Plant (960A05) FCRM Workshop, BHP Road (960A07) Technical Services Building, Snow gum Lane (960A08) Gully Shelter, BHP Road (960A09) Milch, Schuss Street (960A10) Lift Company Building, Village Bowl (960A11) Primary School, Slalom Street
Populations Supplied	120 -1,500 (Summer) to 5,000 (Winter)	
Substances Added	Nil

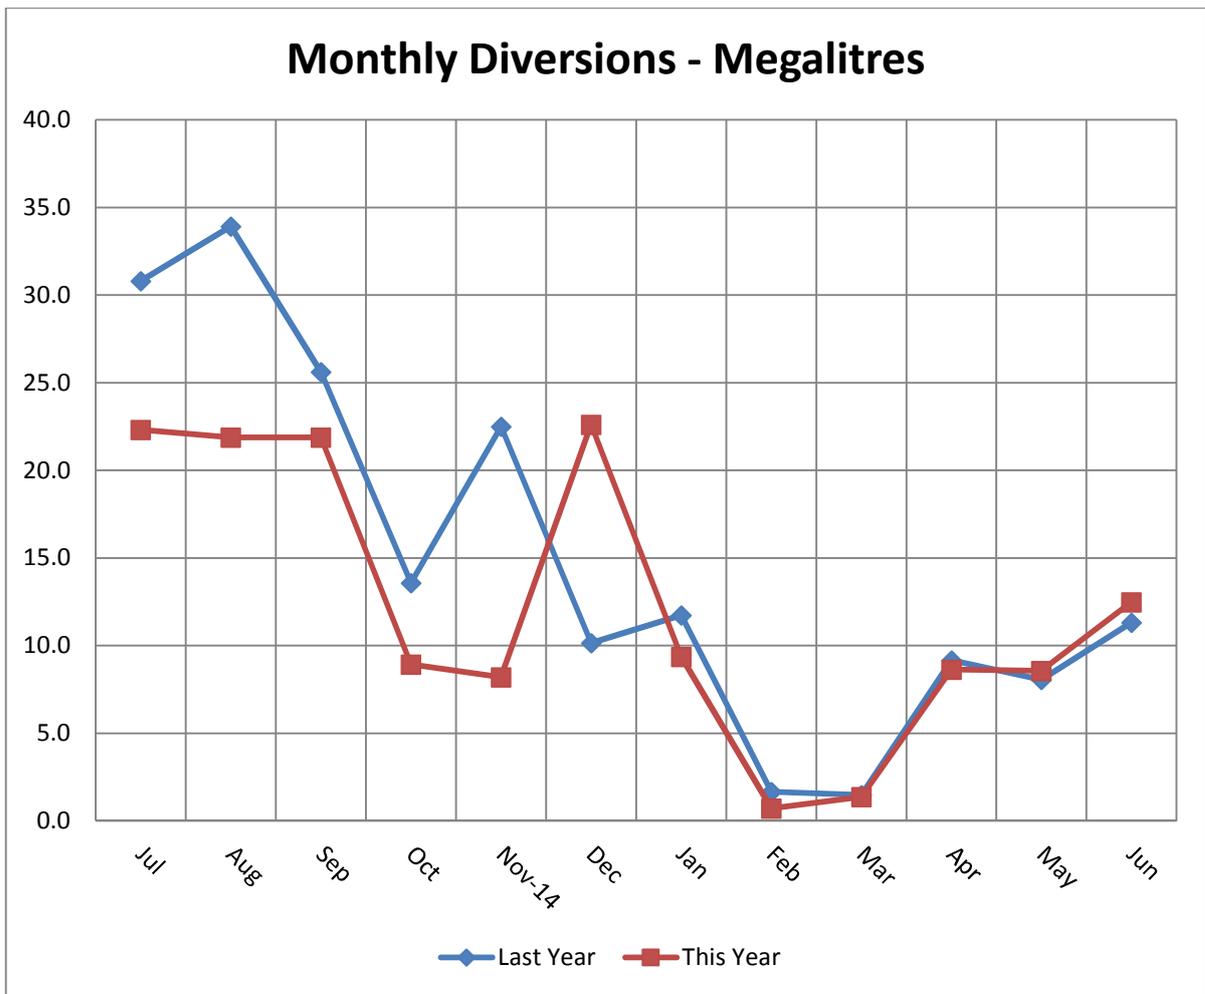
The winter seasonal nature of highest consumptive use is demonstrated in the following graph of monthly diversions.

Year	Volume Diverted (ML)
2014-15	147
2013-14	180
2012-13	195
2011-12	171
2010-11	198
2009-10	231

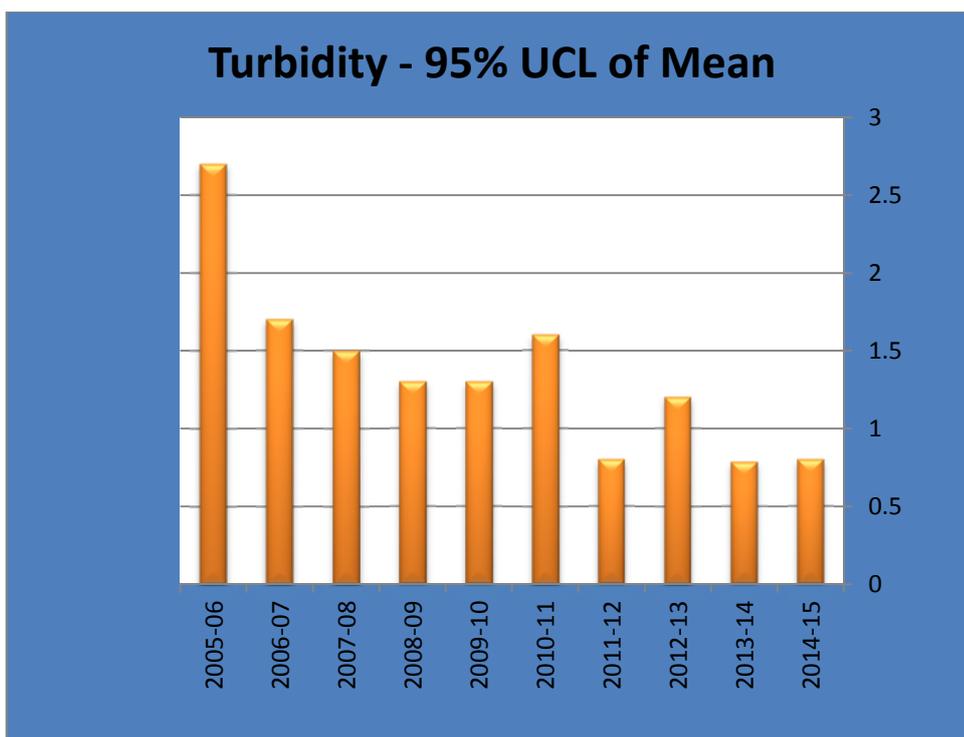
Improved operational procedures in relation to the source water in recent years (refer also to section 4.3) has seen a gradual improvement in the 95% upper confidence limit of the mean as demonstrated in the graph below.

Year	Sampling Frequency	No. of samples	Max NTU	Min NTU	95% UCL of mean	Complying (Yes/No)
2014-15	Weekly	52	3.1	0.1	0.8	Yes
2013-14	Weekly	52	2.3	0.2	0.8	Yes
2012-13	Weekly	52	4.4	0.2	1.3	Yes
2011-12	Weekly	52	0.2	1.6	0.8	Yes
2010-11	Weekly	51	12	0.3	1.6	Yes
2009-10	Weekly	52	3.1	0.3	1.3	Yes

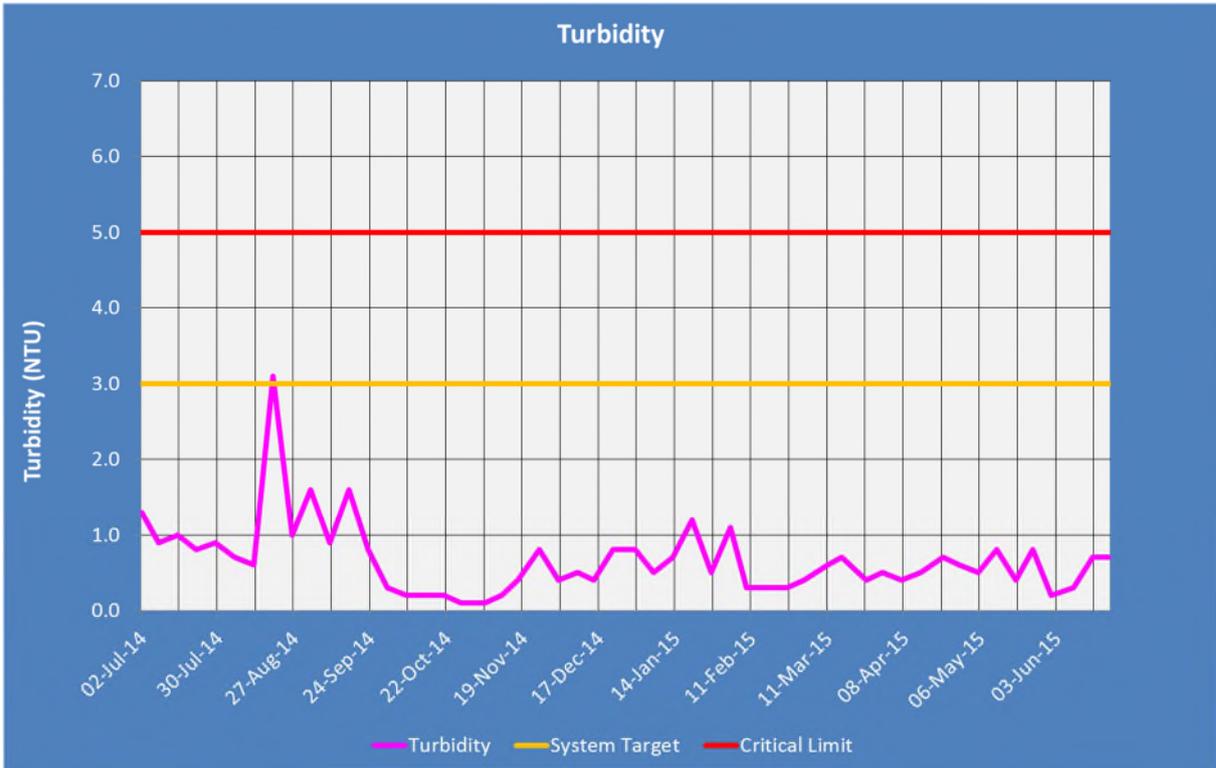
Weekly turbidity readings for the year are show graphically below.

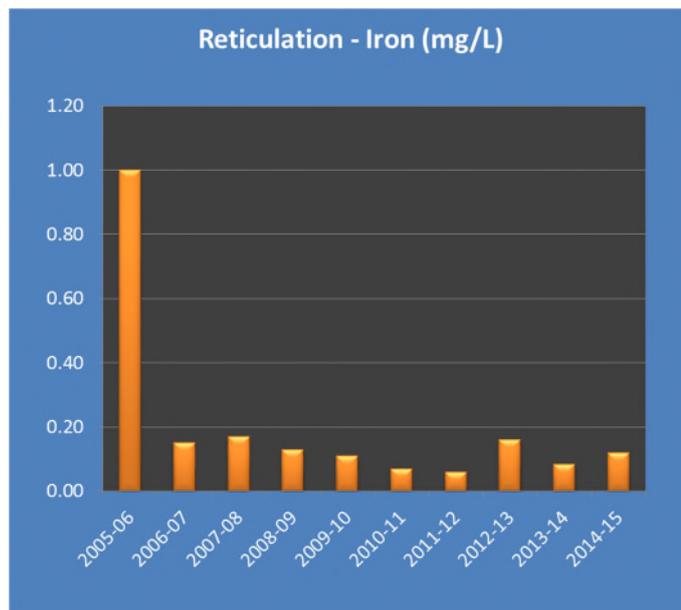
The water quality testing regime shows that the source water in the dam suffers from dirty water problems in late summer and mid-winter. This is reflected in elevated levels of dissolved iron and manganese which causes a characteristic brown tinge to the water. Improved operational responsiveness to the change in quality of the source water by taking supply from alternative sources (aqueduct or the snow making system) during periods of stagnation in summer started in 2006-07. This has produced a marked improvement in the tested iron levels in the reticulated supply. The trend in dealing with this issue is demonstrated in the graph of annual average levels shown below. For further detail refer also to section 4.3 below.
