Water Quality Annual Report

2016/17

Falls Creek Alpine Resort – Water Quality Annual Report 2016-17

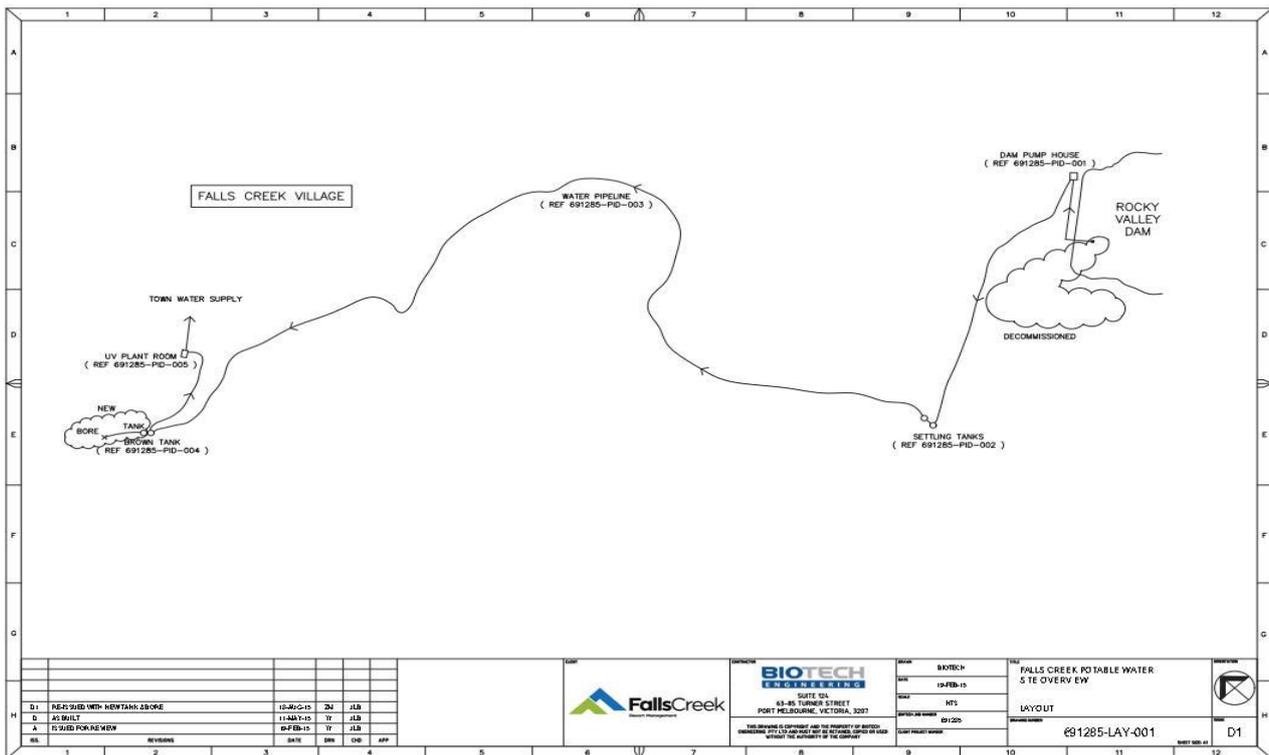
Figure 1 - Diagram of supply system

The current duty of the previous supply system elements upstream of the storage tanks (Rocky Valley Dam supply) is primarily required as back-up for firefighting, supplemental supply during peak demand and to provide an alternate source in the event of a supply failure of the ground water system. With a planned second vertical production bore, reliance on Rocky Valley Dam will be further reduced.

- New storage facility inlet works provided the capacity for FCARMB to fill the storage tanks (Brown and Blue) either from the groundwater source or from surface water in Rocky Valley Dam;
- A new UV Treatment System was introduced which replaced the old technology UV with two "state of the art" UV units. The two new UV water treatment units operate simultaneously. The automation system controls the operation and monitors the status of the water UV treatment units.

- An intake within the Rocky Valley Dam;
- A pumping station, that transferred water from the Dam to two Settling Tanks;
- Two Settling Tanks, which provided a means to allow any residual suspended solids to be removed. However, it should be noted that the water in the dam was usually of a high quality and clarity;

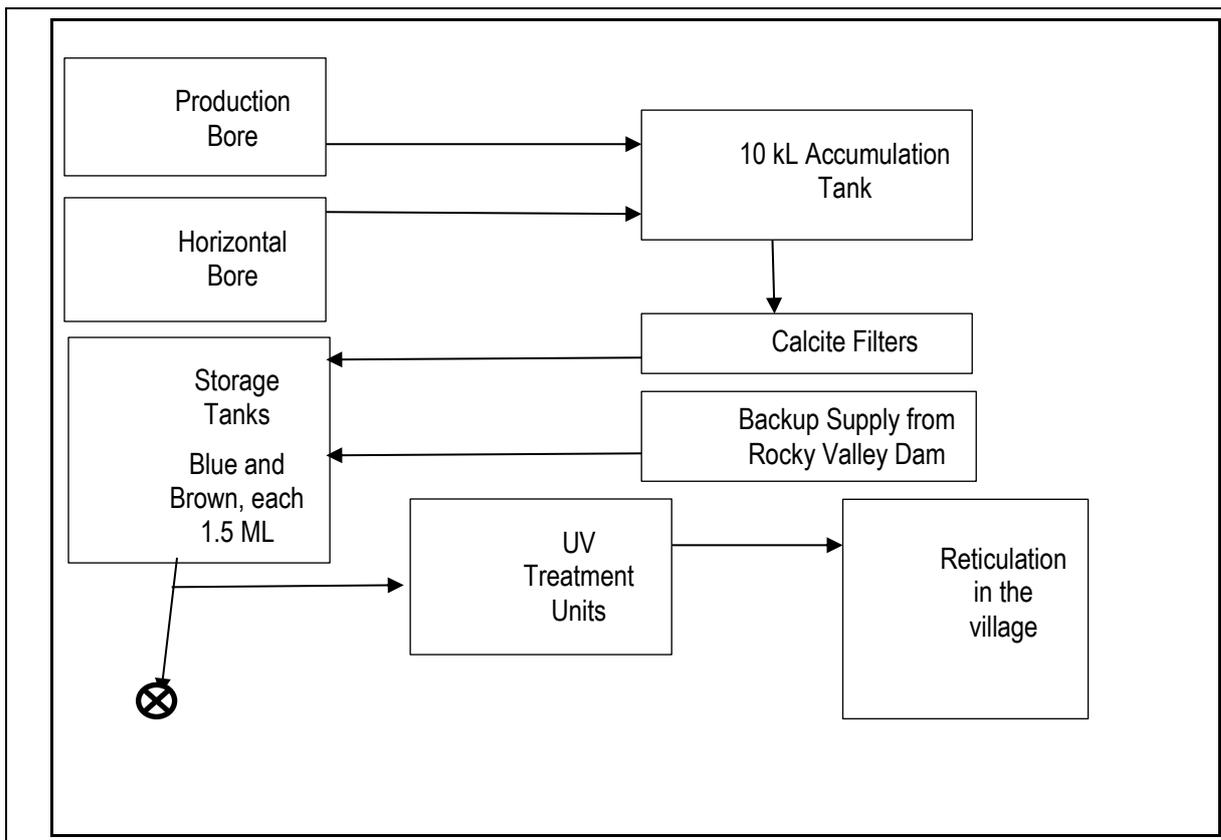
Figure 2 Schematic Diagram of Bore, Horizontal Drains, Accumulation Tank, Calcite Filter, Header Tanks, UV system and UV By-pass.

A Horizontal Bore is also linked to the Drinking Water Supply. This bore is part of a system of bores that were constructed to facilitate hydrostatic depressurisation of geological features in the vicinity of the Falls Creek village.

source. All pipework between the bore surface casings and the Accumulation Tank is underground to prevent damage and freezing during winter.

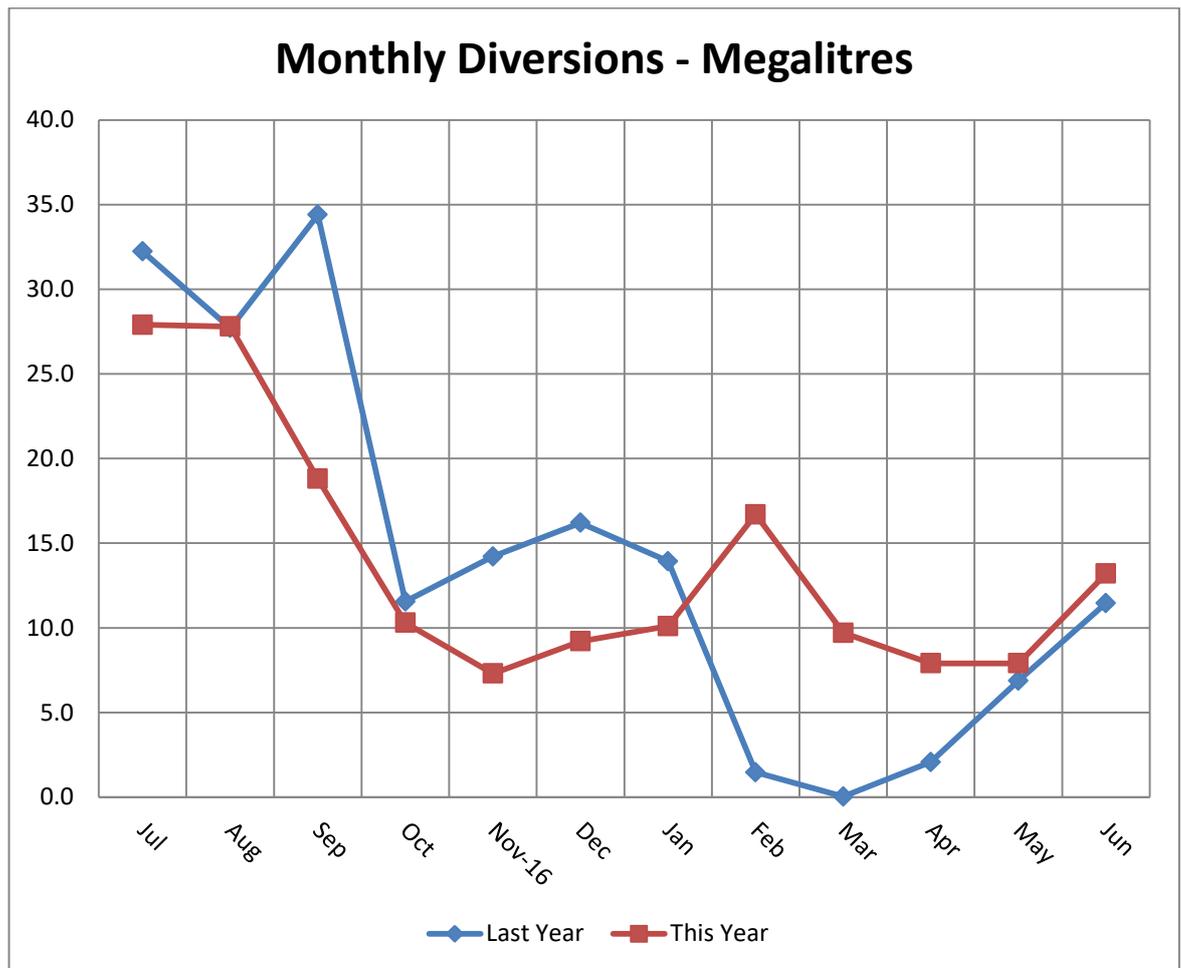
The winter seasonal nature of highest consumptive use is demonstrated in the following graph of monthly diversions.

Year	Volume Diverted (ML)
2016-17	167
2015-16	162
2014-15	147
2013-14	180
